**HAZARDOUS MATERIALS INSPECTION REPORT
FOR THE
MONTGOMERY COLLEGE – GERMANTOWN CAMPUS
BUILDING #101 – STUDENT AFFAIRS & SCIENCE (SA)
LOCATED AT
20200 OBSERVATION DRIVE
GERMANTOWN, MARYLAND 20876**

AMA Job # 20263
Purchase Order # 62121800

June 8, 2021

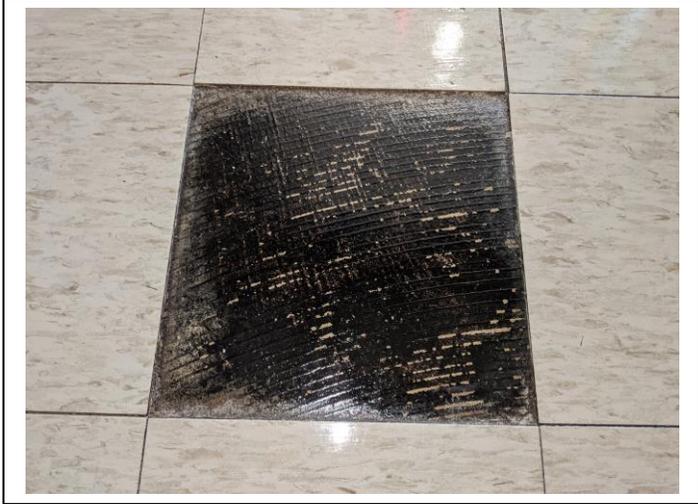
Photo #1
Material: Black floor tile mastic
Sample location: AMA 2-48
Previously Identified ACM (Briggs 1991 report)

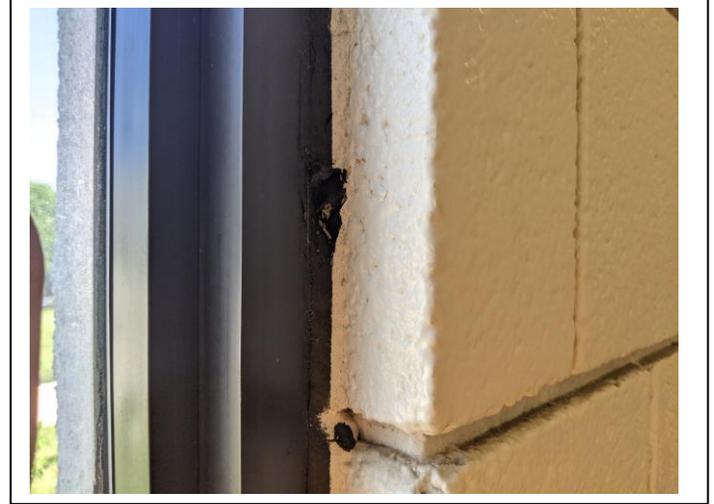
Photo #2
Material: Brown interior window system caulk
Sample location: AMA S-1
(3-4% Chrysotile)

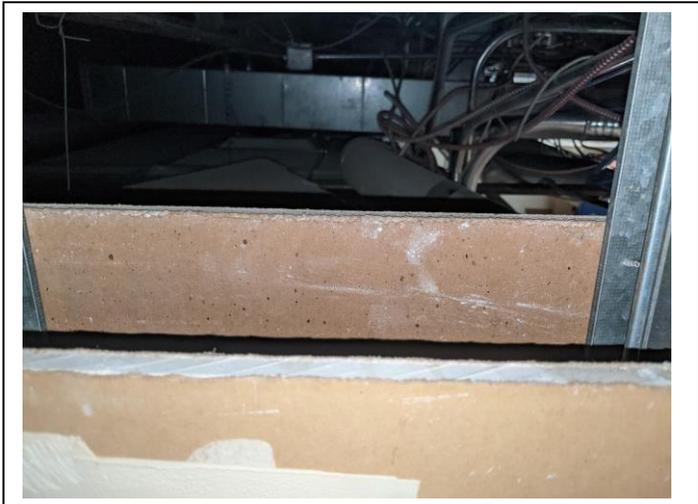
Photo #3
Material: Drywall and drywall joint compound
(newer/white)
Sample location: AMA 2-48
(2% Chrysotile)

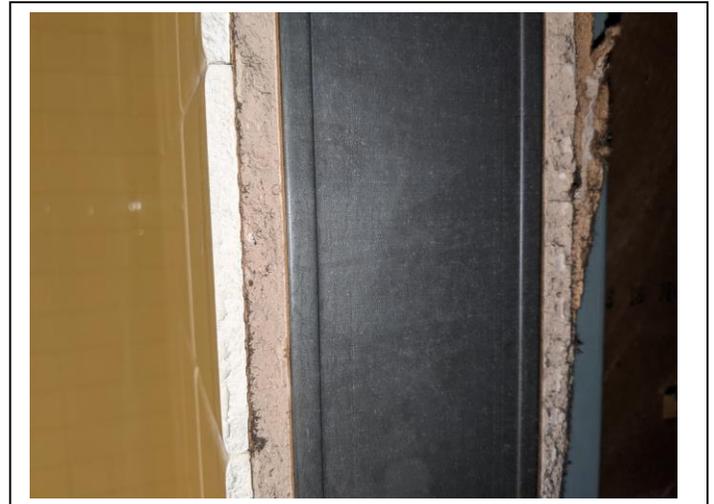
Photo #4
Material: Drywall and drywall joint compound
(older/brown)
Sample location: AMA 2-13
(2% Chrysotile)

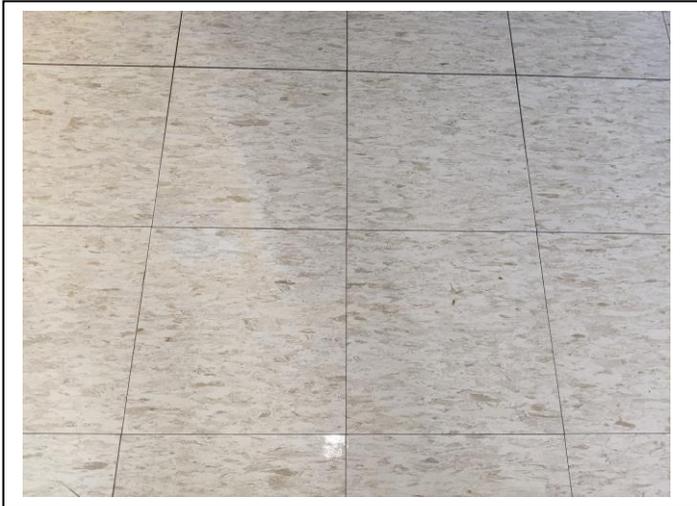
Photo #5

Material: 12"x12" Tan mottled floor tile
Sample location: AMA 2-48
(2% Chrysotile)

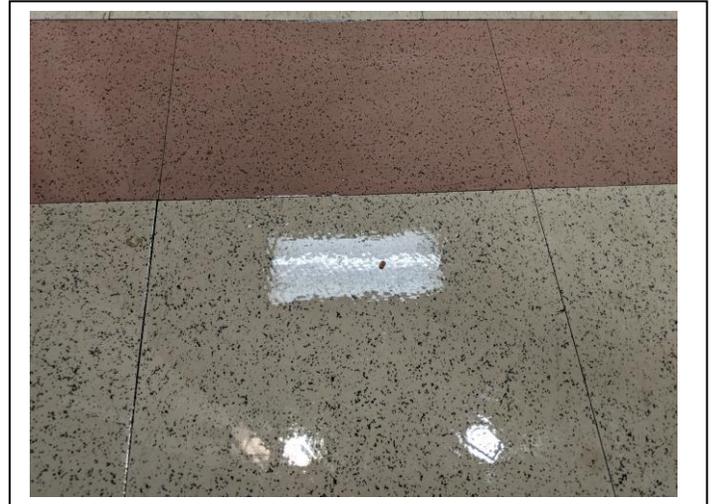
Photo #6

Material: 12"x12" Yellow with black dots floor tile
and 12"x12" Pink with black dots floor tile
Sample location: AMA 1-19
**Adhered to asbestos-containing black floor tile
mastic**

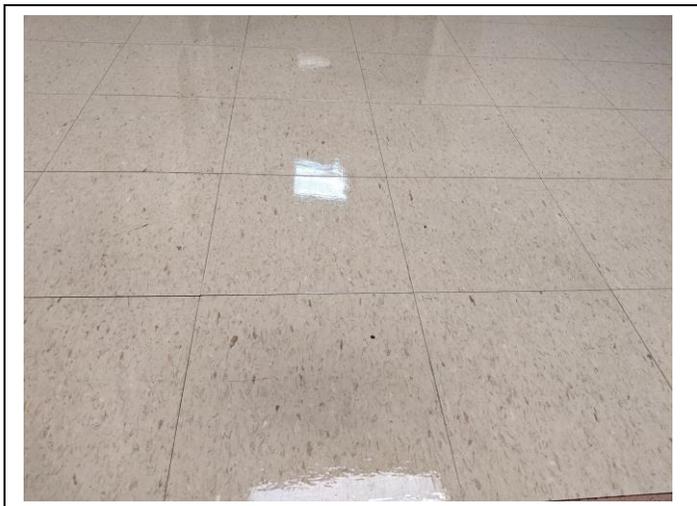
Photo #7

Material: 12"x12" Tan with brown specks floor tile
Sample location: AMA 1-19
**Adhered to asbestos-containing black floor tile
mastic**

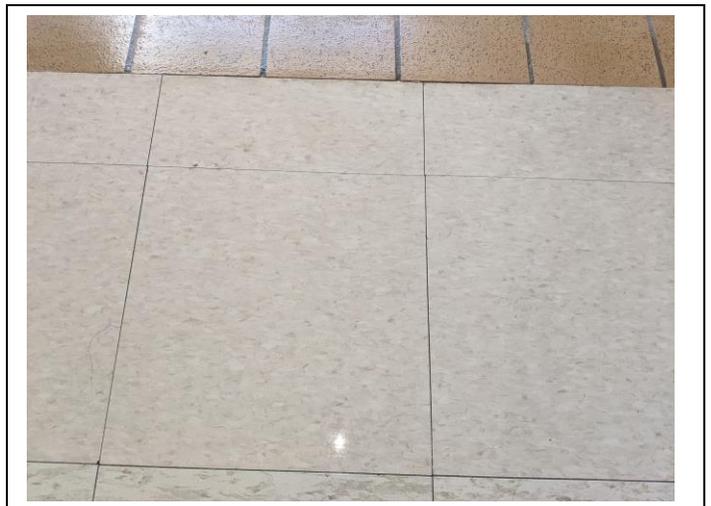
Photo #8

Material: 12"x12" Beige mottled floor tile
Sample location: AMA S-1
**Adhered to asbestos-containing black floor tile
mastic**

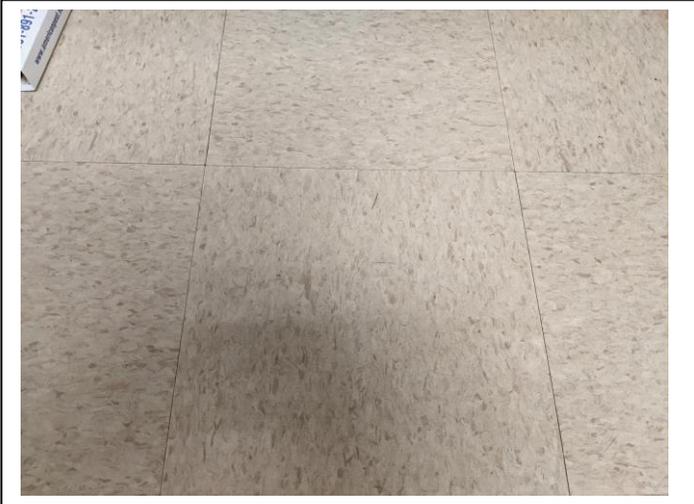
Photo #9

Material: 12"x12" Tan striated floor tile
Sample location: AMA 1-34
Adhered to asbestos-containing black floor tile mastic

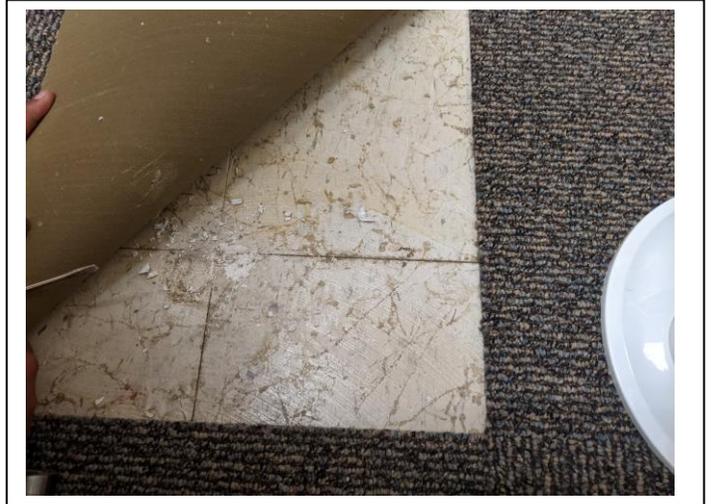
Photo #10

Material: 12"x12" White with gray streaks floor tile
Sample location: AMA 1-42
Adhered to asbestos-containing black floor tile mastic

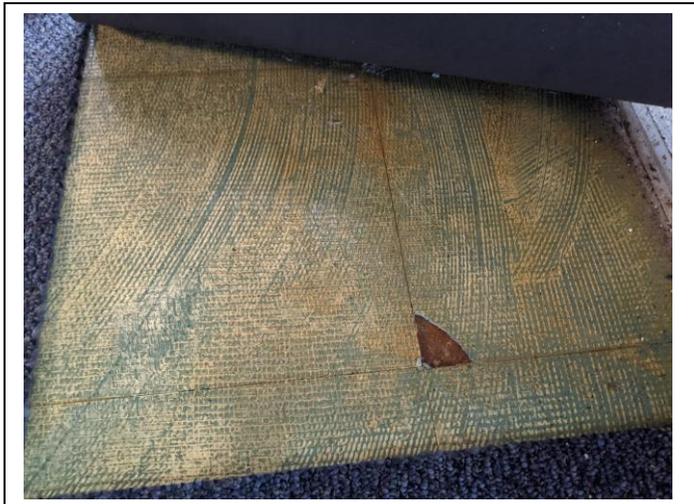
Photo #11

Material: 12"x12" Green with black dots floor tile
Sample location: AMA 1-59
Adhered to asbestos-containing black floor tile mastic

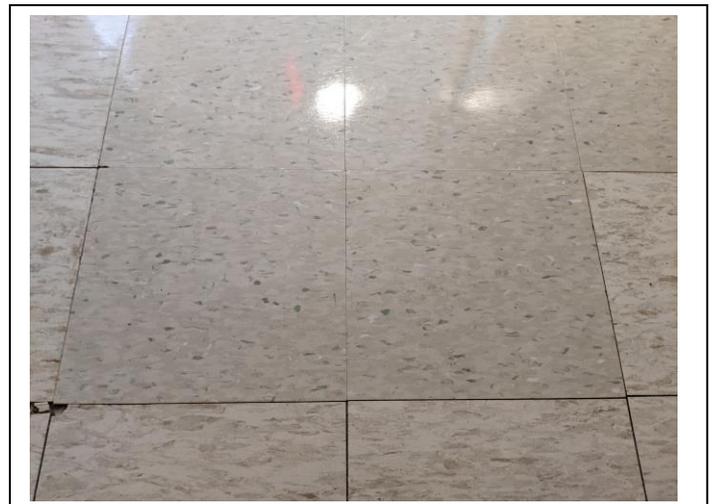
Photo #12

Material: 12"x12" Gray with green specks floor tile
Sample location: AMA 2-48
Adhered to asbestos-containing black floor tile mastic

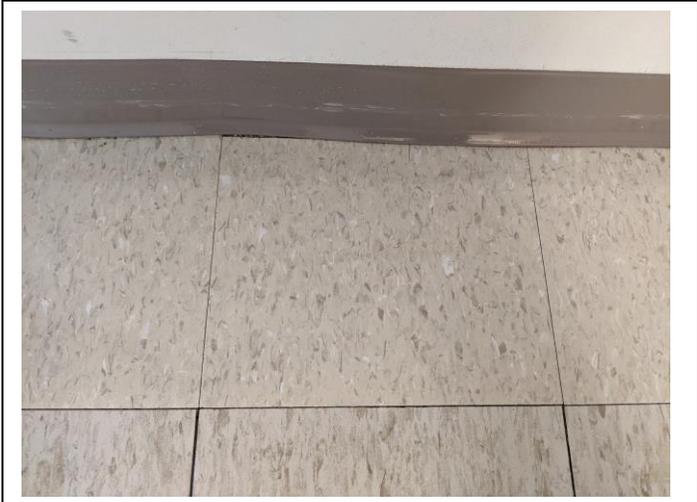
Photo #13

Material: 12"x12" Tan with white and brown specks floor tile
Sample location: AMA 2-48
Adhered to asbestos-containing black floor tile mastic

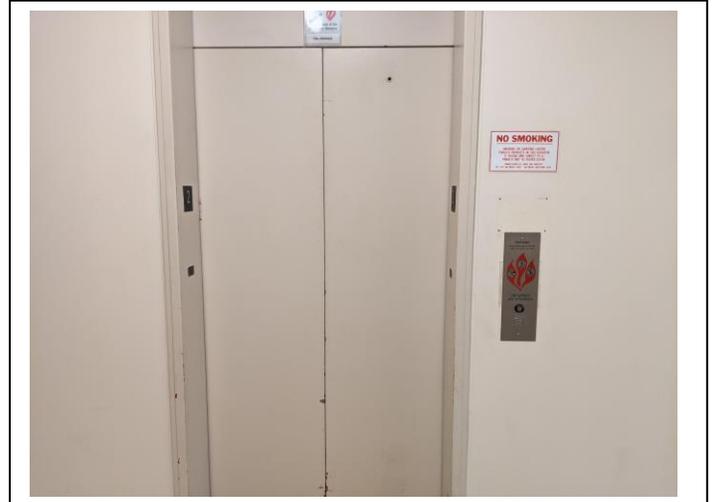
Photo #14

Material: Elevator door insulation (assumed)
Sample location: AMA 2-48
Assumed ACM

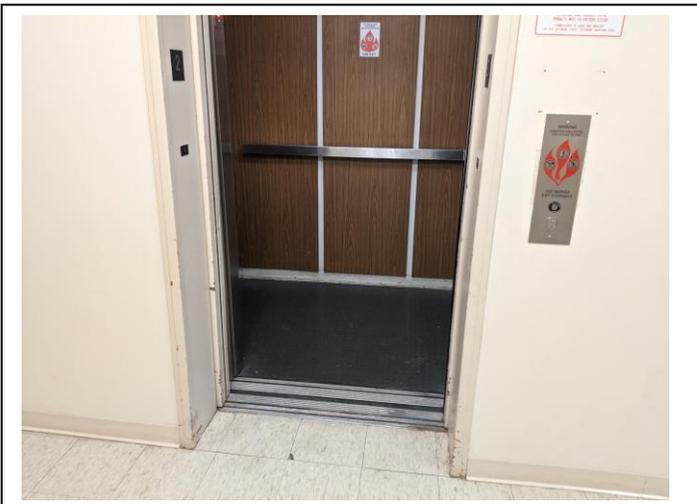
Photo #15

Material: Elevator cab wall insulation (assumed) and elevator cab floor sheet mastic dots (assumed)
Sample location: AMA 2-48
Assumed ACM

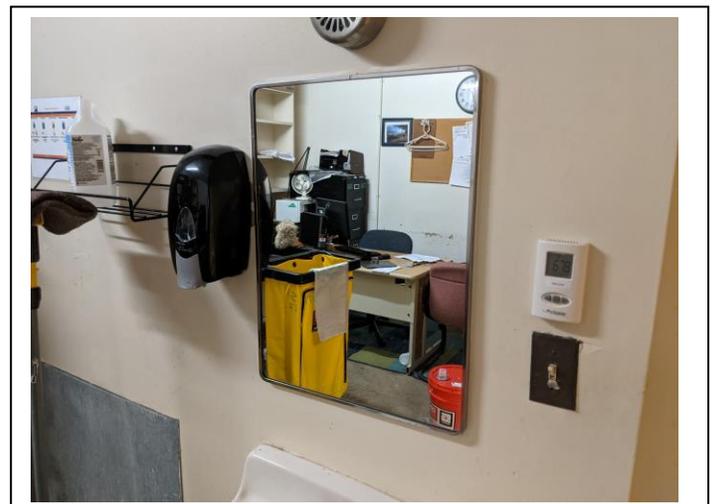
Photo #16

Material: Mirror mastic (assumed)
Sample location: AMA 1-30
Assumed ACM

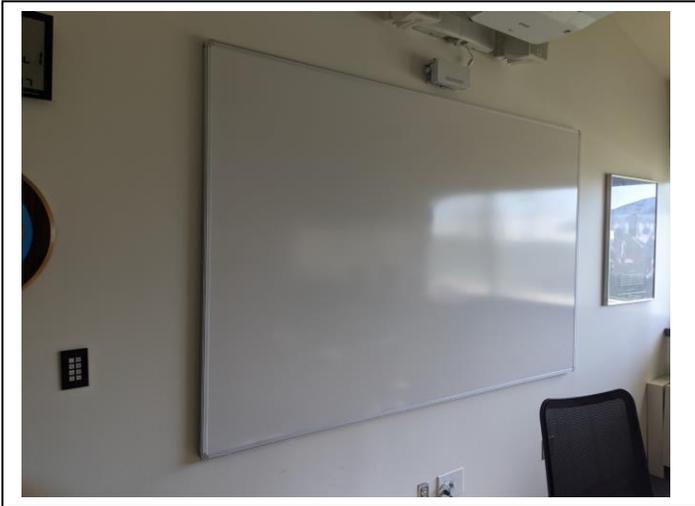
Photo #17

Material: Chalkboard/whiteboard/pinboard mastic
(assumed)

Sample location: AMA 1-02
Assumed ACM

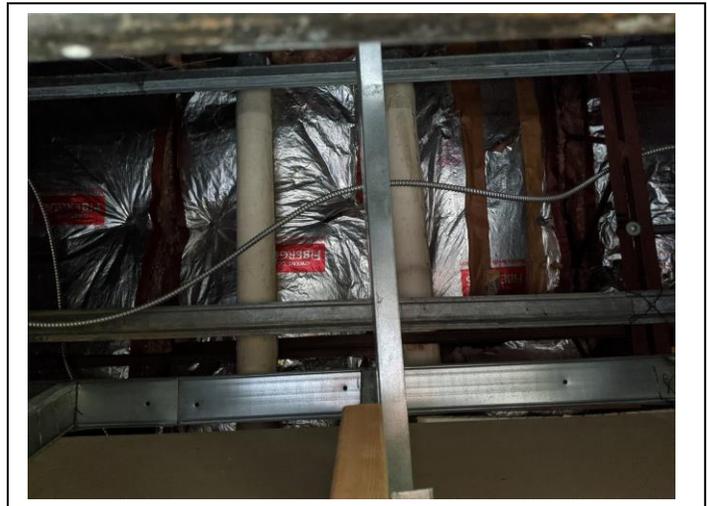
Photo #18

Material: Brown ceiling deck insulation pin mastic
(assumed)

Sample location: AMA 1-05
Assumed ACM
