Rockville Campus – Robert Parilla Performing Arts Center
Asbestos Survey map June 1991

MONTGOMERY COLLEGE
ROCKVILLE CAMPUS
PERFORMING ARTS CENTER

ASBESTOS CONTAINING
MATERIALS LOCATION
SCHEMATIC

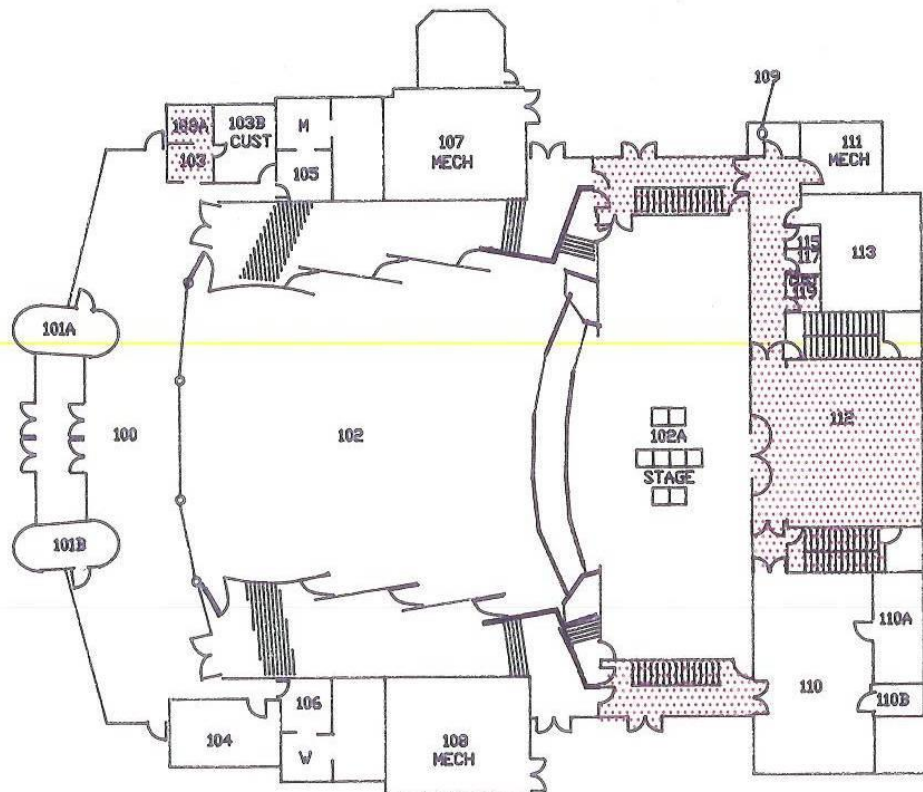
FIRST FLOOR PLAN

Only some of the floor tile is ACM. Floor tile mastic is not ACM

Errata: Sample 3-RPAC is not positive.

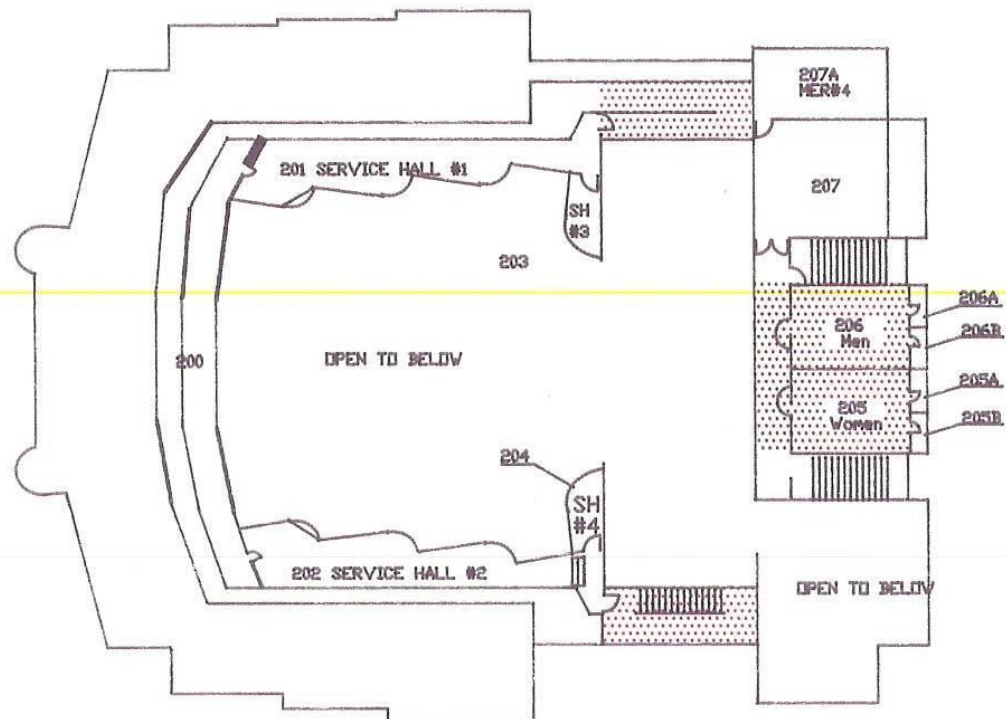
B3

LEGEND
 ASBESTOS CONTAINING
 FLOOR TILE
