Rockville Campus – Robert Parilla Performing Arts Center
Asbestos Survey map June 1991

MONTGOMERY COLLEGE
ROCKVILLE CAMPUS
PERFORMING ARTS CENTER

ASBESTOS CONTAINING
MATERIALS LOCATION
SCHEMATIC

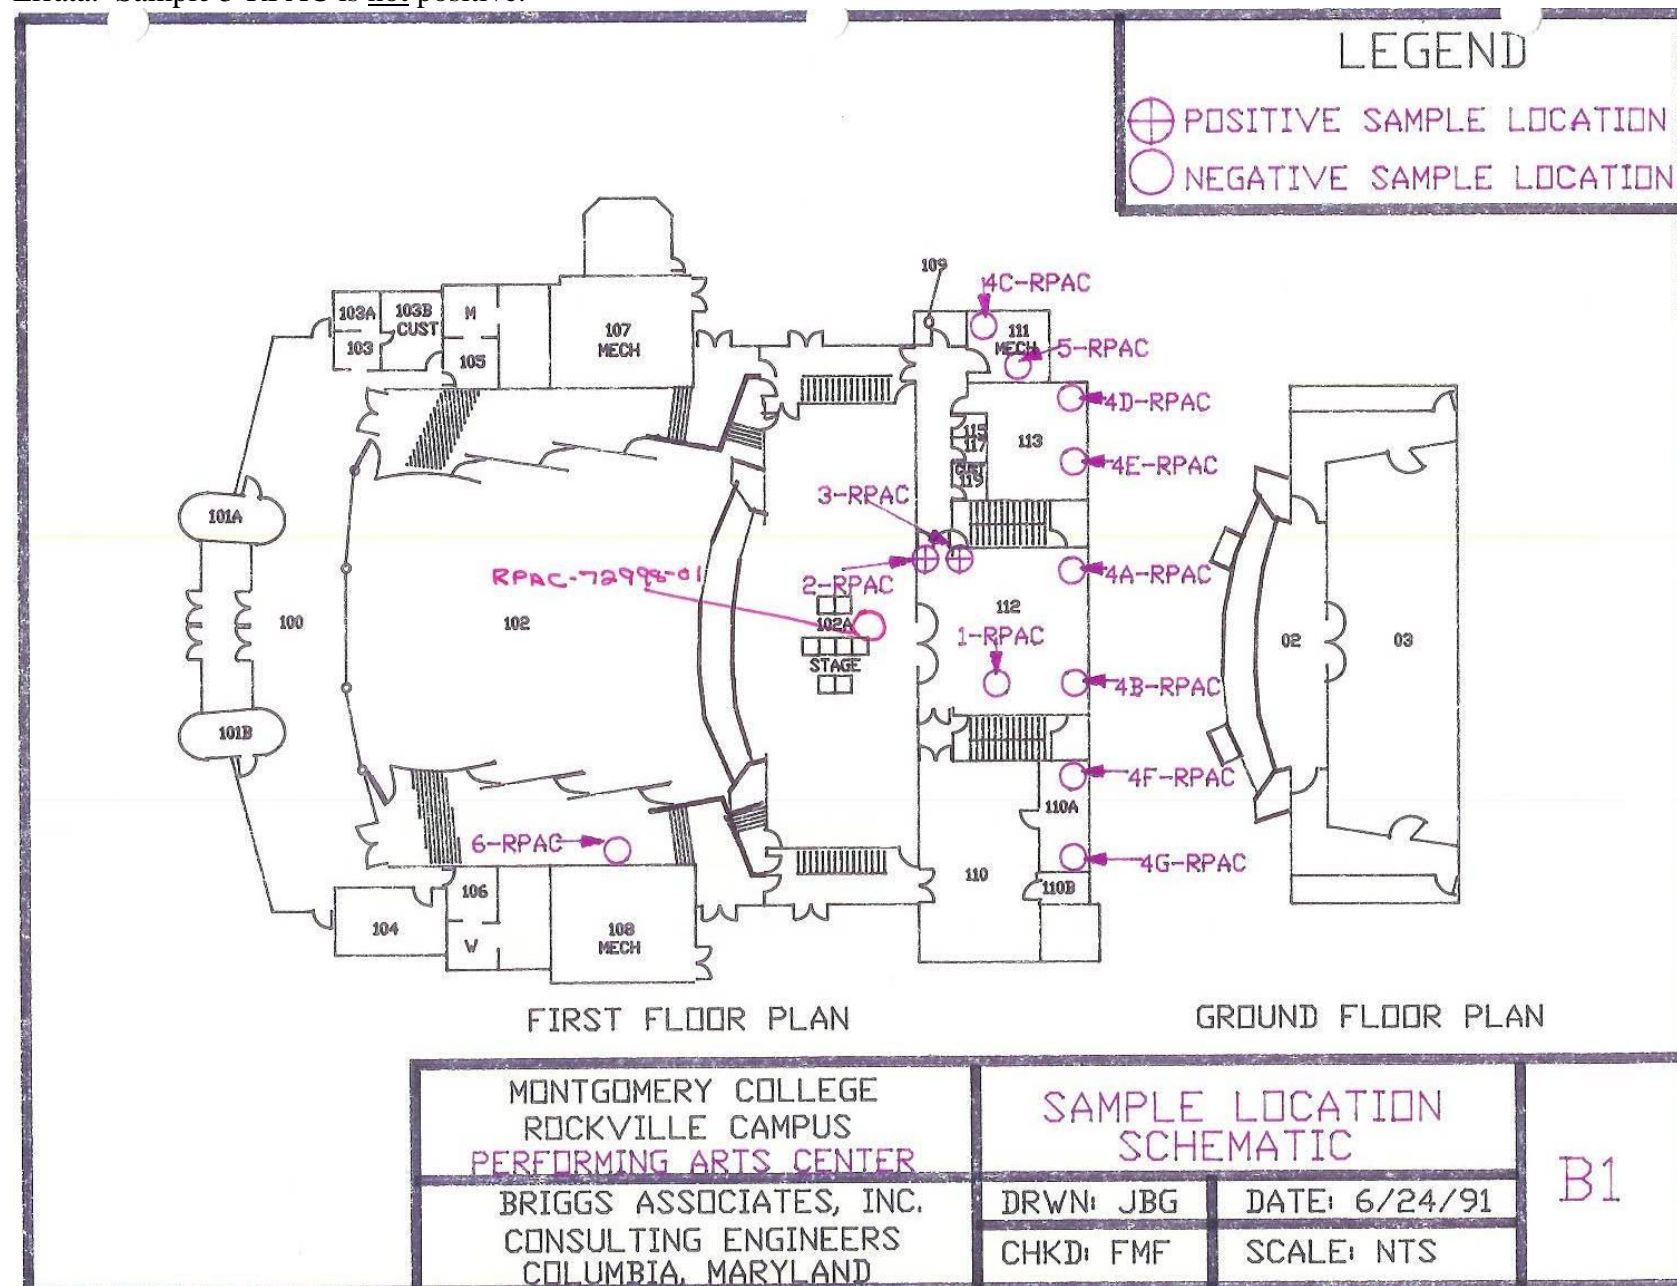
B2

Only some of the floor tile is ACM. Floor tile mastic is not ACM

Errata: Sample 3-RPAC is not positive.

ASBESTOS CONTAINING
FLOOR TILE
