Assessment of Asbestos-containing Building Materials  
Child Care Center - Takoma Park Campus  
Montgomery Community College

CHILD CARE CENTER  
RENOVATION

## Drawing TM1a

## FLOOR PLANS

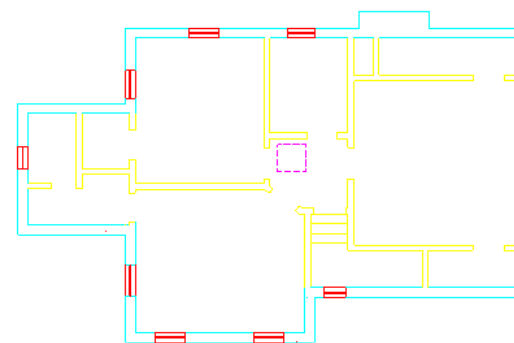
### BASEMENT FLOOR PLAN

<u>Material</u>	<u>Location</u>	<u>Assessment</u>
Pipe. Insulation REMOVED 6/23/93	First Floor Bathroom; Above Ceiling Tile	Significantly . damaged, friable TSI with potential for damage.
Mudded Joint REMOVED 6/23/93	First Floor Bathroom; Above ceiling Tile	Damaged, friable TSI with potential for damage.
Resilient Sheet Flooring (under LN-1/Carpeting)	First Floor; Throughout	Nonfriable miscellaneous material with low potential for damage.
Fire Door REMOVED 2/14/94	Second Floor; Landing	Nonfriable miscellaneous material with low potential for damage.
Electrical Wiring Insulation	Basement; Throughout	Friable miscellaneous material with damage potential.
